SITE INVESTIGATION INSTALLATION RESTORATION PROGRAM (IRP) SITE NO.4 AND SITE NO.5

216th ENGINEERING INSTALLATION SQUADRON & 234th COMBAT COMMUNICATIONS SQUADRON CALIFORNIA AIR NATIONAL GUARD HAYWARD AIR NATIONAL GUARD STATION HAYWARD, CALIFORNIA

MARCH 1996

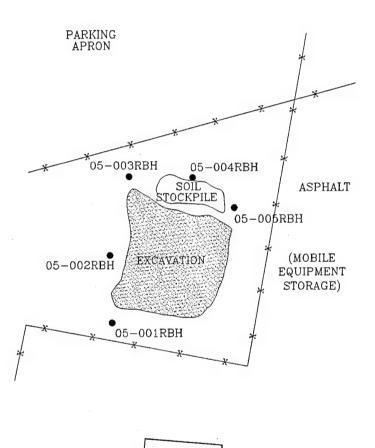
FIGURE 5.24

The soil boring locations at IRP Site No. 5 are indicated on Figure 5.24. Soil borings 05-002BH and 05-003BH, originally proposed in the Work Plan to the east and southeast of the excavation, respectively, were relocated because they were overlain by concrete. Subsequently, three soil borings were located along the north perimeter of the excavation, one boring was located immediately west of the excavation, and one boring was located off the southwest corner of the excavation.
